I found a bug

M. Simon

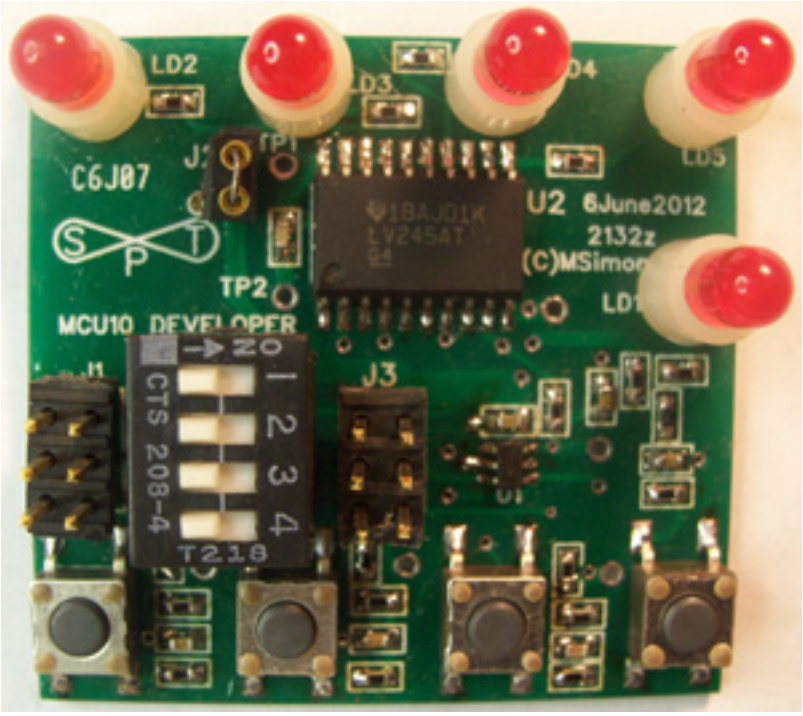
So I fired up Atmel Studio 6 [4] and checked out the device. According to the programmer the device has 5.0 volts on it. According to my uncalibrated meter the power supply reads 4.95 volts. Close enough.

[1]The program assembled with no errors (after a few tries) and so I tried to program the chip. No luck. I got an error code. Plus I could not read the device ID. After trying this quite a few times with the
