Bearing damage: A lurking problem in electric cars

Matthew Roman, Engineering Manager, Electro Static Technology

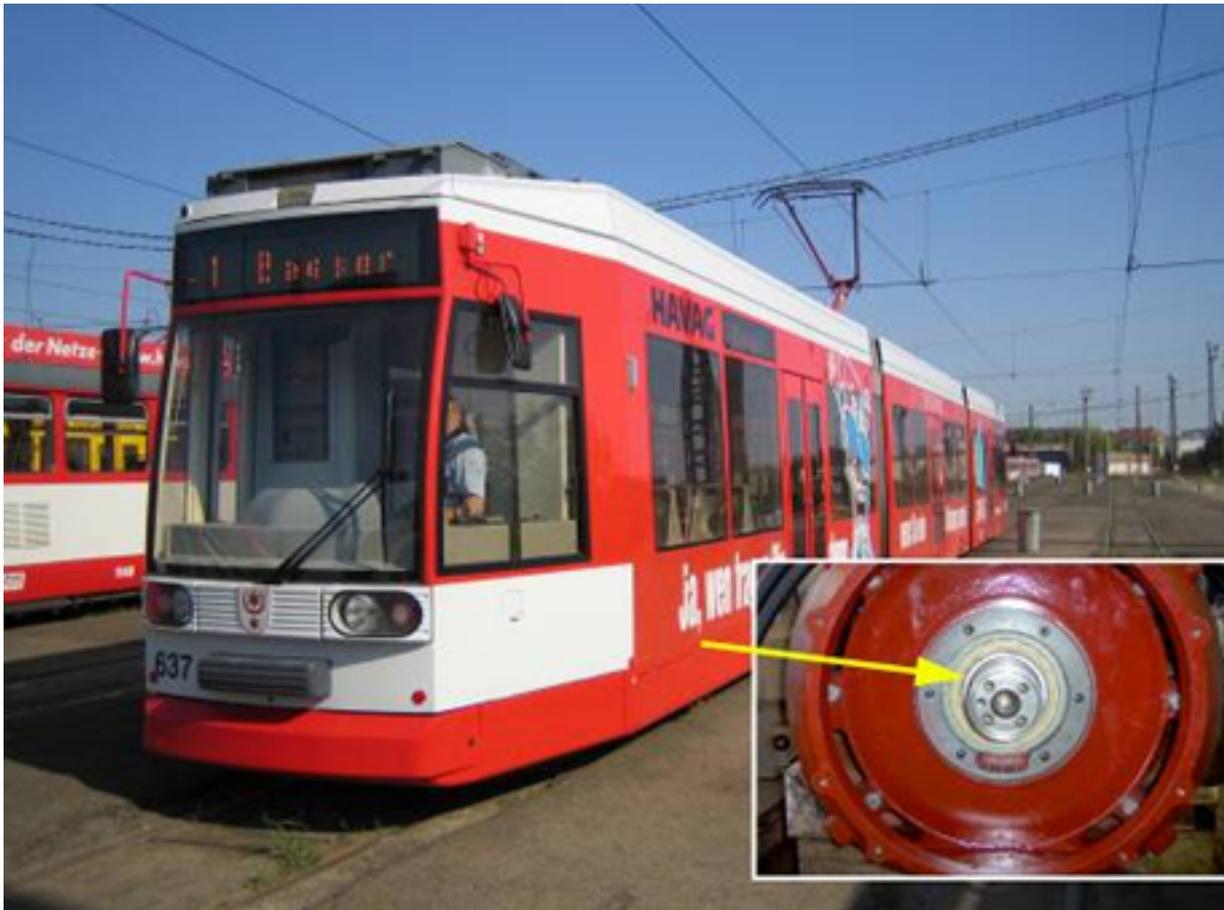
Figure 1. This all-electric tram in Halle (Saale), Germany, suffered bearing damage from inverter-induced voltages until the problem was solved in 2007 with the installation of an AEGIS SGR Bearing Protection Ring (inset) on the shaft of every traction motor in the fleet. The city has had an electric tram system since 1891.

One of the most reliable and cost-effective grounding devices is a ring that fits over the motor’s shaft [Figure 1]. Engineered with specially designed conductive microfibers, the AEGIS SGR Bearing Protection Ring safely channels damaging currents to ground, bypassing the bearings entirely. Scalable to any NEMA or IEC motor regardless of shaft size or horsepower, the ring has been installed successfully on motors powering pumps, fans, turbines, conveyors, etc., in hundreds of thousands of installations worldwide. More recently, the AEGIS ring has proven itself effective in the inverter-controlled traction motors of electric trucks, trains, trolleys [Figure 2], and construction equipment. It is now being tested by several auto manufacturers, though quietly, due to non-disclosure agreements.

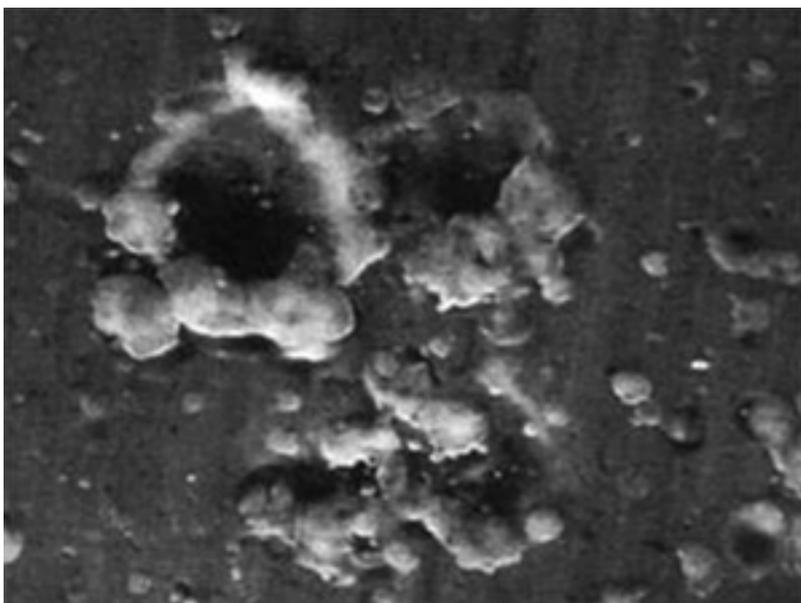
Figure 2. EDM pitting of a bearing race wall (magnified) — the result of inverter-induced electrical discharges from the motor shaft.

switching circuitry. The extremely fast voltage rise times (dV/dt) associated with the insulated gate bipolar transistors (IGBTs) typically found in today's pulse-width-modulated inverters can cause charges to build up on the motor shaft. Without mitigation, these voltages discharge through bearings, causing unwanted electrical discharge machining (EDM) that erodes ball bearings and race walls and leads to premature bearing/motor failure.

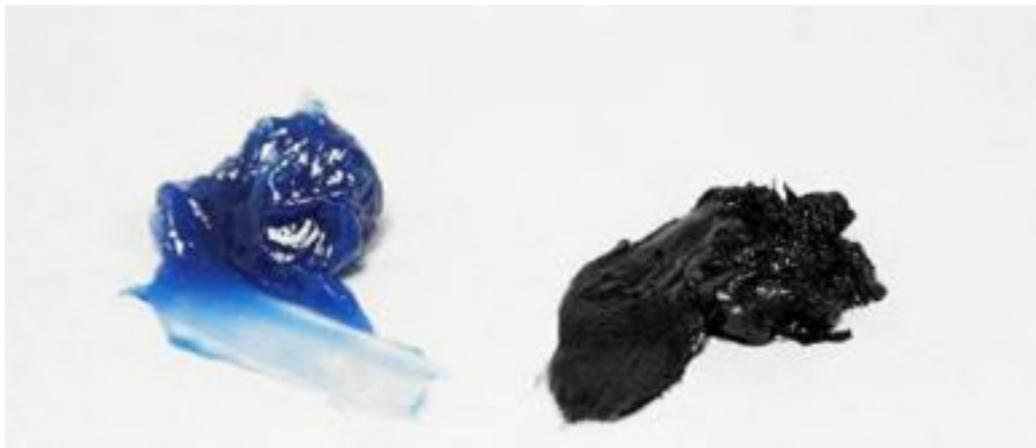
Figure 3. New (left) and used (right) bearing grease. Burned and contaminated with particles of steel from EDM pitting, the used grease provides less lubrication and thus further shortens bearing life.

Electric motors in vehicles operate in a range from 1,000 to over 16,000 rpm, and at such speeds the very thin grease layer between the rolling elements and race in a bearing can break down due to voltage discharges of 5 to 40 volts. Every time the grease dielectric is overcome, an electrical arc through the bearing burns the grease and blasts a tiny pit (fusion crater) in the steel surface [Figure 2]. At inverter carrier frequencies of over 12 kHz, many millions of pits can be created in a very short time. This process also generates steel and carbon particles that contaminate the grease, further reducing its lubrication properties and giving it a black "burnt" color [Figure 3].

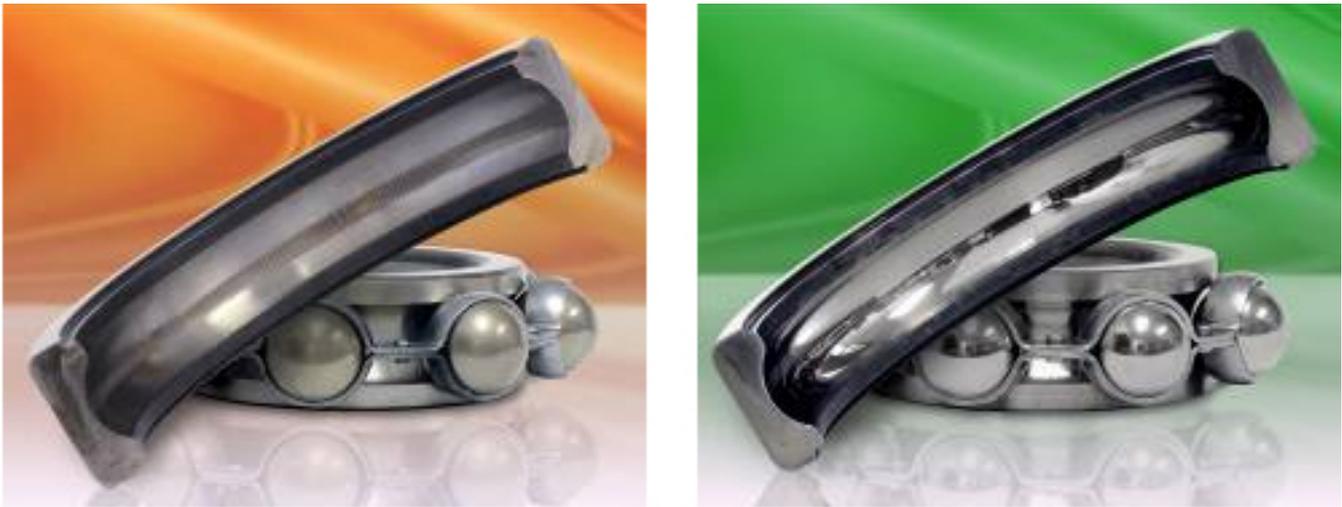
Figure 4. Taken from a failed motor, the “fluted” bearing race wall (left) resulted from VFD-induced bearing currents.

Before long, frequent discharges can leave the entire bearing race riddled with pits known as frosting. In a phenomenon called fluting, the operational frequency of the inverter causes concentrated pitting at regular intervals along the bearing race wall, forming washboard-like ridges that result in noise and vibration [Figure 4].
